IMPORTANT SAFETY RECALL NOTICE

| Subject Öhlins TTX36 Shock absorbers | Date 03/25/2015 | Page 1(3) |

Öhlins Racing AB has determined that a defect which relates to motor vehicle safety exists in **certain batches and part numbers** of aftermarket TTX36 (TTX GP, TTX RT & TTX36 MKII) MC shock absorbers produced between 11-06-2013 and 02-19-2015.

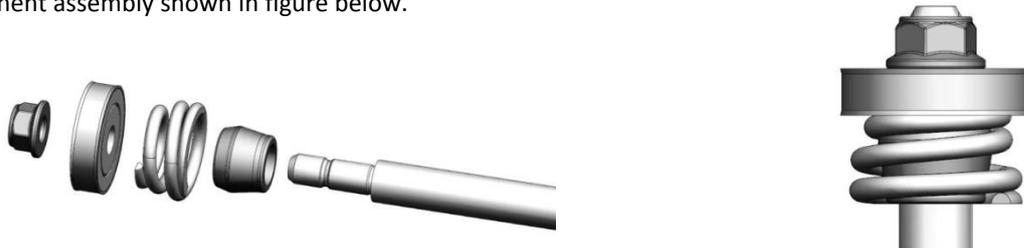
The cause for this defect is the piston-shaft nut which in some cases has not been torqued at full metal to metal contact because the top out spring is preventing the piston to reach its final position due to high friction.

Component assembly shown in figure below.

If the piston-shaft nut comes loose the result will be loss of damping and on some applications it can also cause the shock absorber to come apart. Either of these events may surprise the rider in a way that the rider would no longer have full control of the motorcycle, increasing the risk of a crash.

We therefore strongly urge you to stop using the bike until the shock absorber has been removed or corrected! It can be a safety issue to use the bike with the faulty shock absorber on the bike.
